TCNA TEST REPORT NUMBER: TCNA-0081-18 **PAGE:** 1 OF 6

TEST PROCEDURE: ASTM C627: "A Standard Test Method for Evaluating Ceramic Floor Tile Installation Systems Using the Robinson-Type Floor Tester"

TEST SUBJECT MATERIAL: Identified by client as: "STRATA_HEAT System on 1/4" Hydro Ban Board"

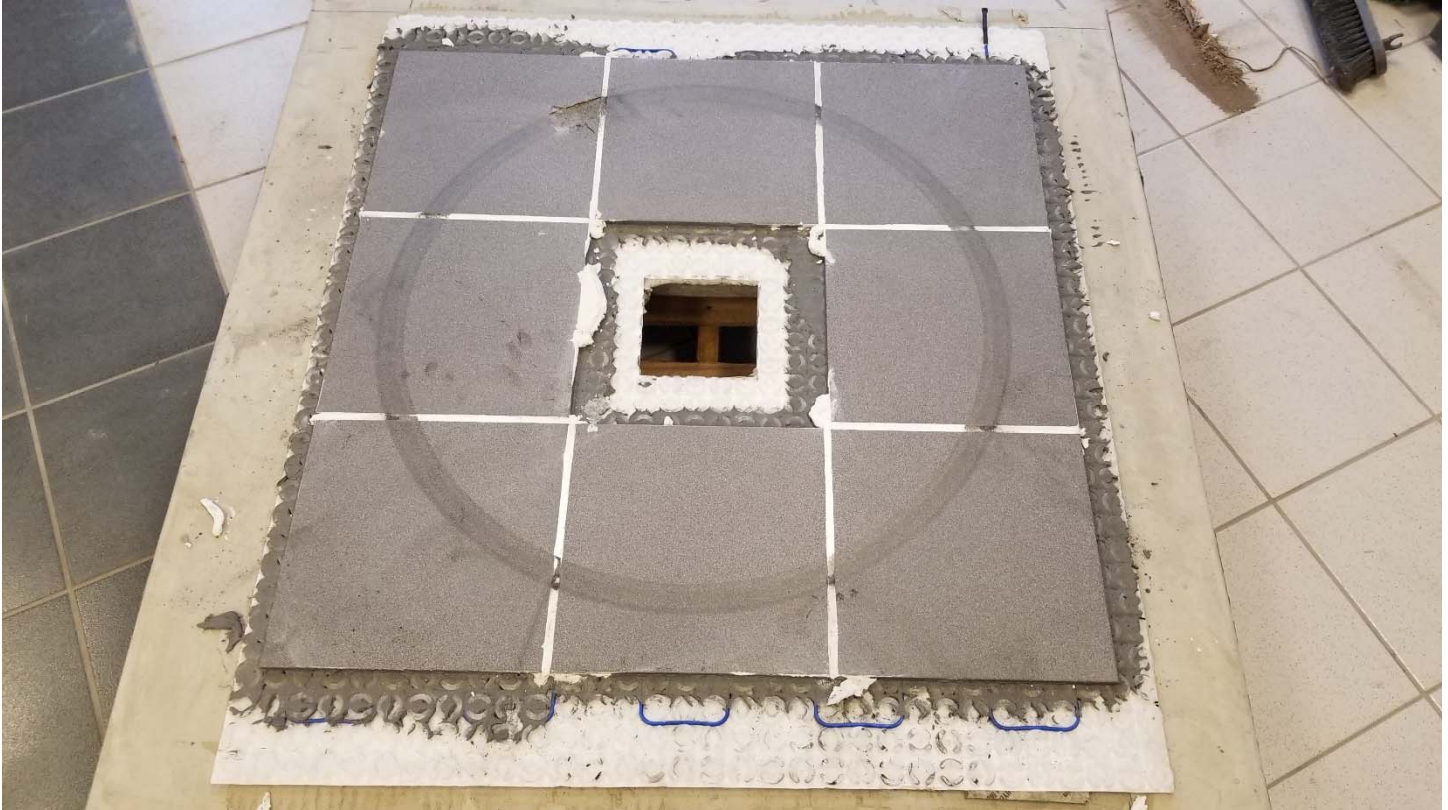
Image 1: Full assembly after testing

Cycle	Wheels	Weight (lb)	Observations
1	Soft Rubber	100	No damage observed.
2		200	No damage observed.
3		300	No damage observed.
4		300	No damage observed.
5	Hard Rubber	100	No damage observed.
6		200	No damage observed.
7		300	No damage observed.
8		300	1 broken tile (Test was stopped due to the extent of the damage potentially causing damage to the test equipment).
9	Steel	50	
10		100	
11		150	
12		200	
13		250	
14		300

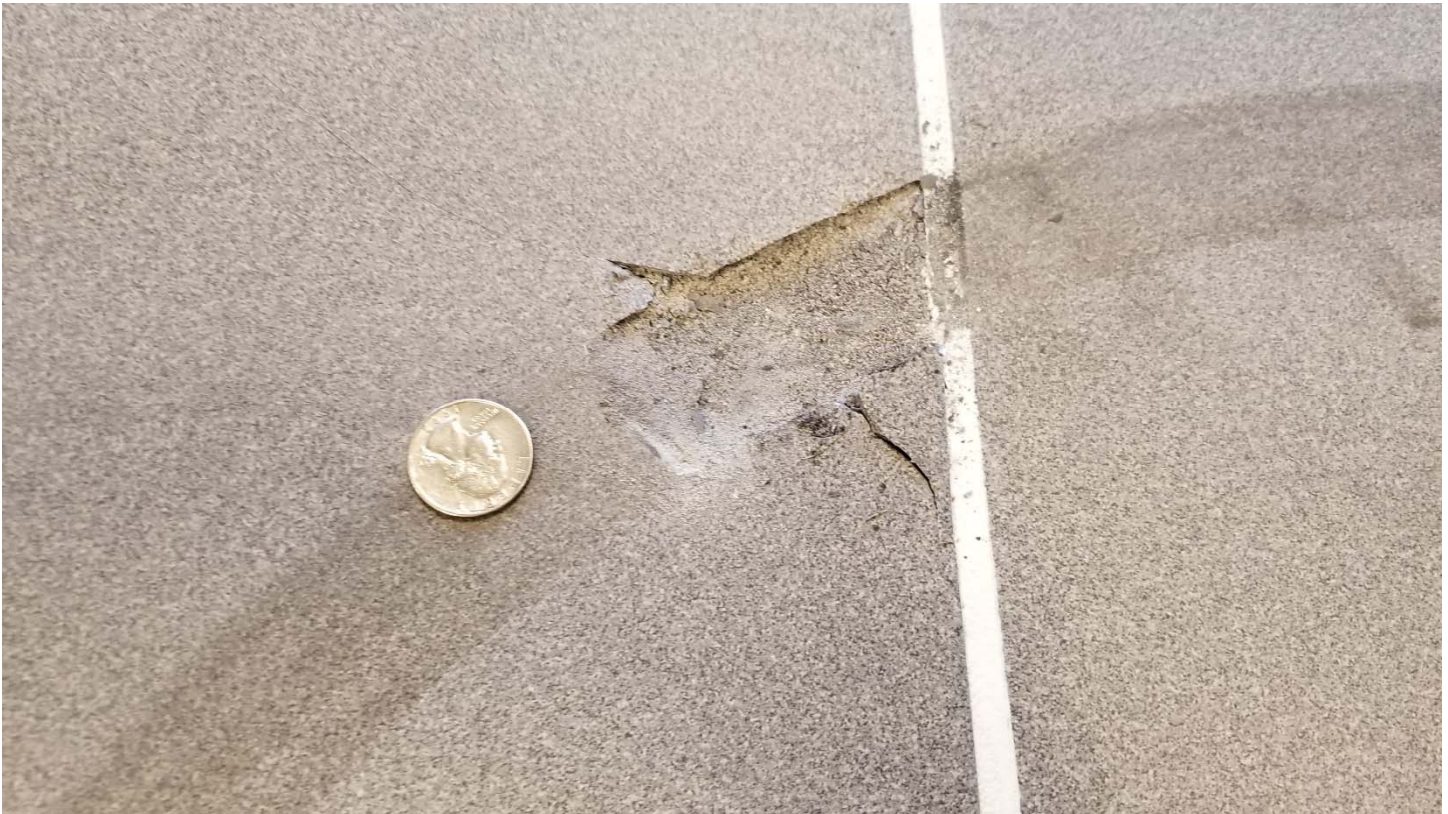
Image 2: Broken Tile
