Coatings Preserve Premium Beachfront Parking

Recoat 4,800 sq. ft. (445.93m²) parking garage in upscale Florida condo complex

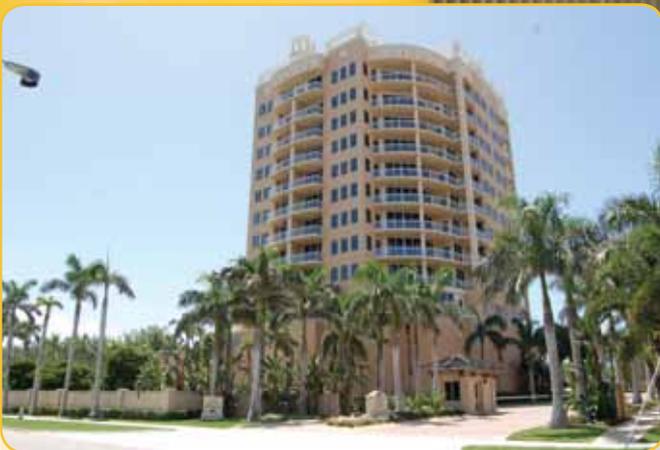
ABOVE ▲ The residents at the Ritz Carlton Beach Residence condominium complex in Lido Beach, Florida were lucky enough to always have access to beach-front parking. But their luck started to turn when their parking garage became a slip-and-fall worry.

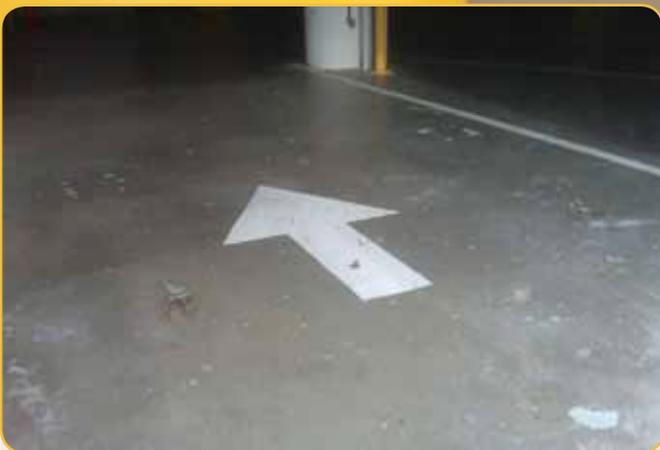
ABOVE ▲ “We had five days to remove the unknown sealer, repair, and recoat the 4,800 square foot (445.93m²) second deck of the parking garage,” says Plumb.

Although the building is managed by the Ritz Carlton, it is separate from the hotel property and the residents have their own set of rules and regulations and concerns. In the case of this coatings project, the first, and most rigid, was the time frame. “We had five days to remove the unknown sealer, repair, and recoat the 4,800 square foot (445.93m²) second deck of the parking garage,” says Plumb. “Although it was technically the second deck, it was actually the entrance into the

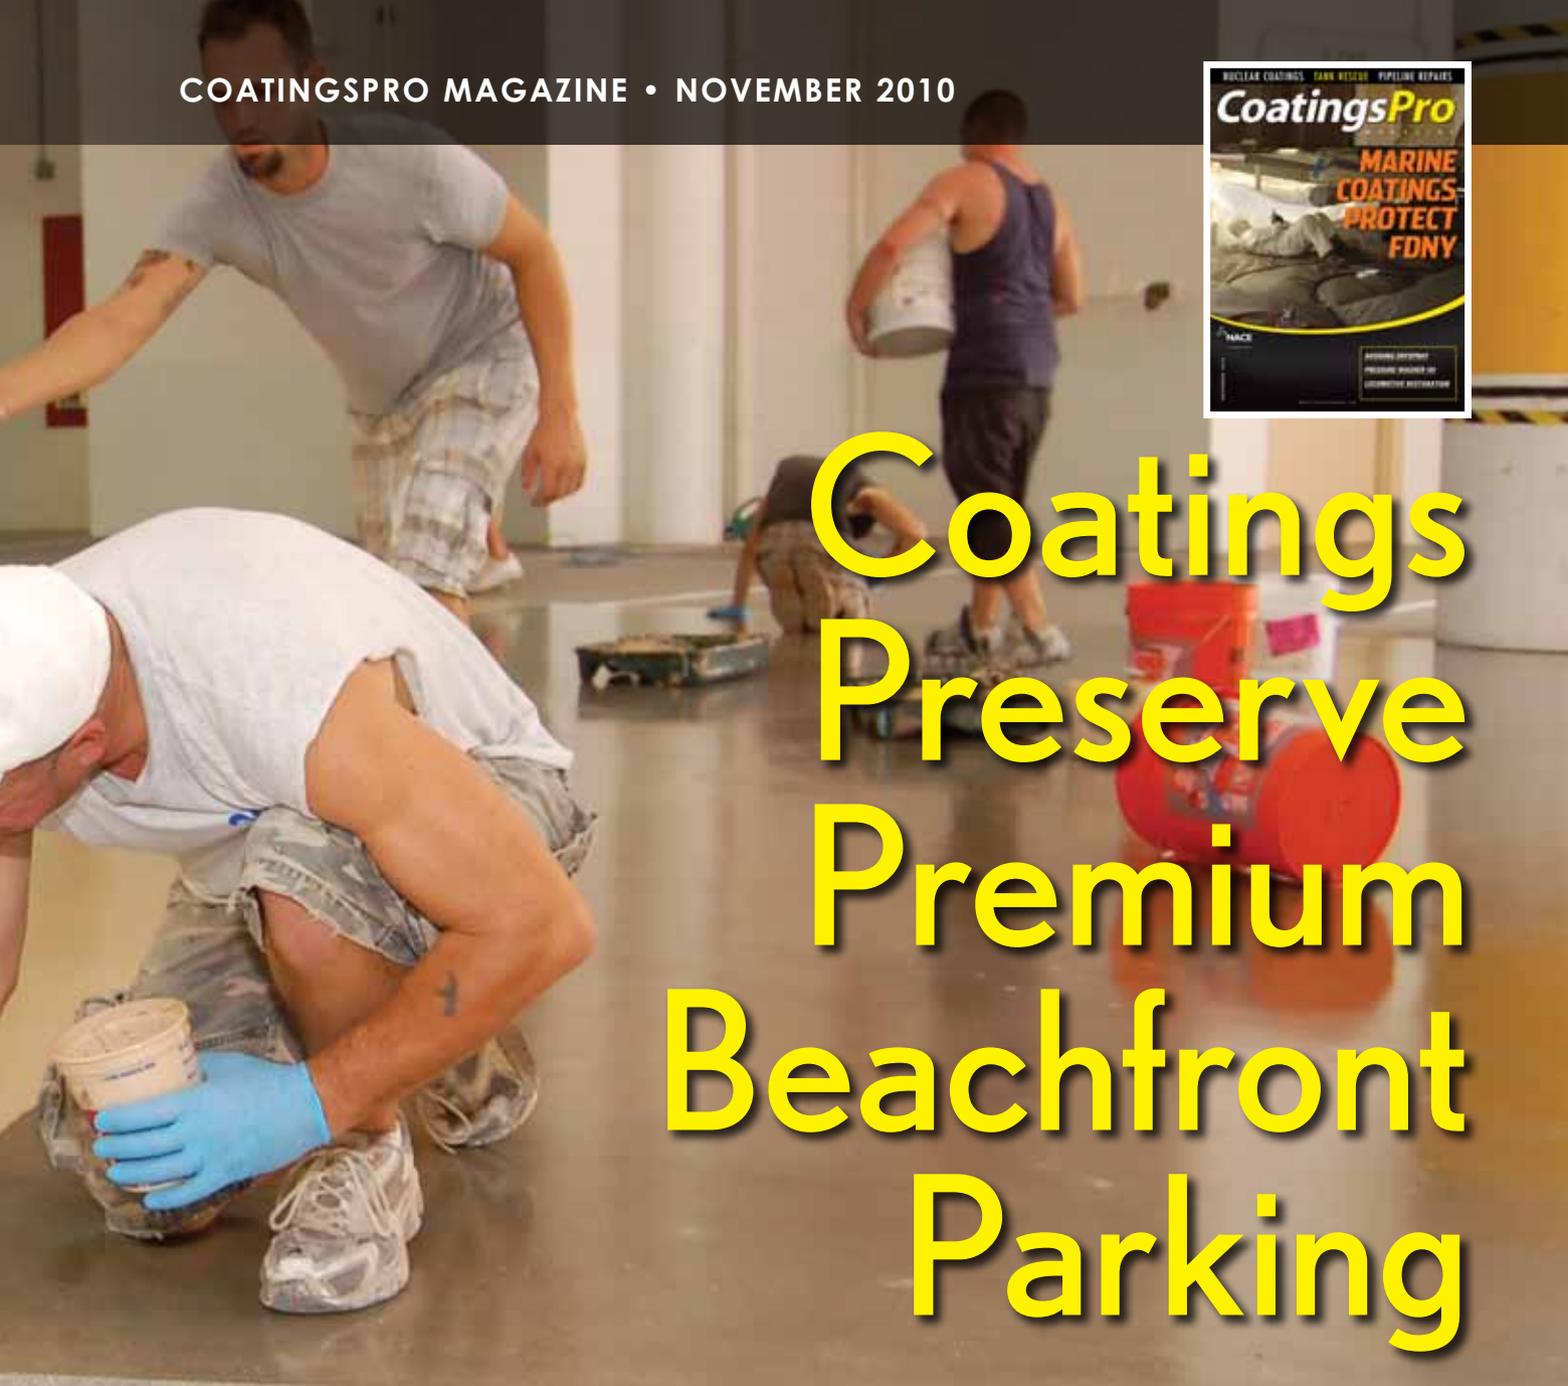
ABOVE ▲ “In addition to being one of the hardest floors, it was also one of the most unusual — especially for Florida — there weren’t any expansion joints or cracks in the entire surface,” describes Plumb.

As soon as the 8am bell rang, the Trademark crew dove right in to the prep work. "In addition to being one of the hardest floors, it was also one of the most unusual – especially for Florida. There weren't any expansion joints or cracks in the entire surface," describes Plumb. And as far as joints went, they weren't going to cut any. "Since the parking deck was the structure's second floor, we were not allowed to drill any holes or make any cuts in the slab. We could only surface grind."

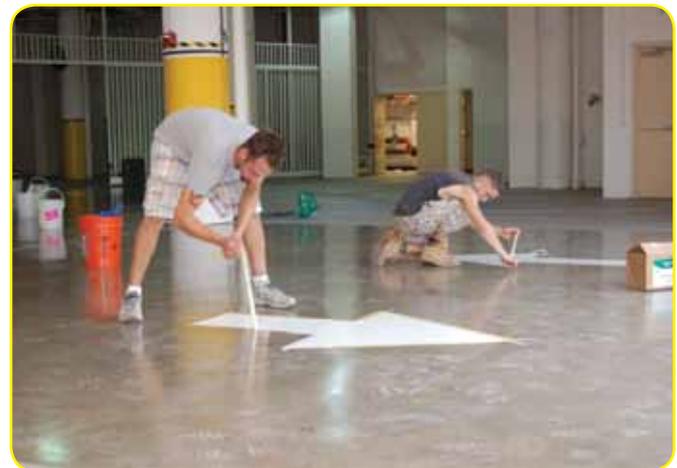
ABOVE ▲ The crew also used a vinyl painter's mask and HP Spartacote SpartaFlex in both white (for the logo) and blue (for the background), as well as the 18" rollers to roller-apply handicap logos to several of the parking spots.

They used three coats of HP Spartacote’s SpartaFlex in white at 10 mils (0.25mm) DFT total for the lines and arrows. They also used a vinyl painter’s mask and HP Spartacote SpartaFlex in both white (for the logo) and blue (for the background), as well as the 4" rollers to roller-apply handicap logos to several of the parking spots. “For the handicap spots we applied two coats of the blue or white and one coat of clear for a total of 10 mils (0.25mm) DFT,” describes Plumb. While the clear coat was still wet, it was time for the application of the quartz system.

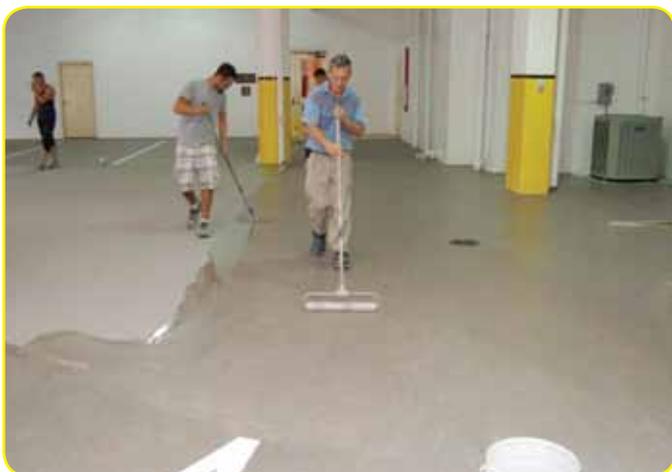
ABOVE ▲ Plumb explains, "We had two guys rolling the coating using 18" (45.72cm) rollers with 3/8" (0.95cm) nap and two guys cutting in, bringing the mixed coating from the mixing station and pouring it for the rollers."

mixing at a 1:1 ratio. But since this product sets up so quickly — it has a one hour recoat window — we only mixed a half-of-a-gallon per crew member,” Plumb continues. “We had two guys rolling the coating using 18" (45.72cm) rollers with 3/8" (0.95cm) nap and two guys cutting in, bringing the mixed coating from the mixing station and pouring it for the rollers.”

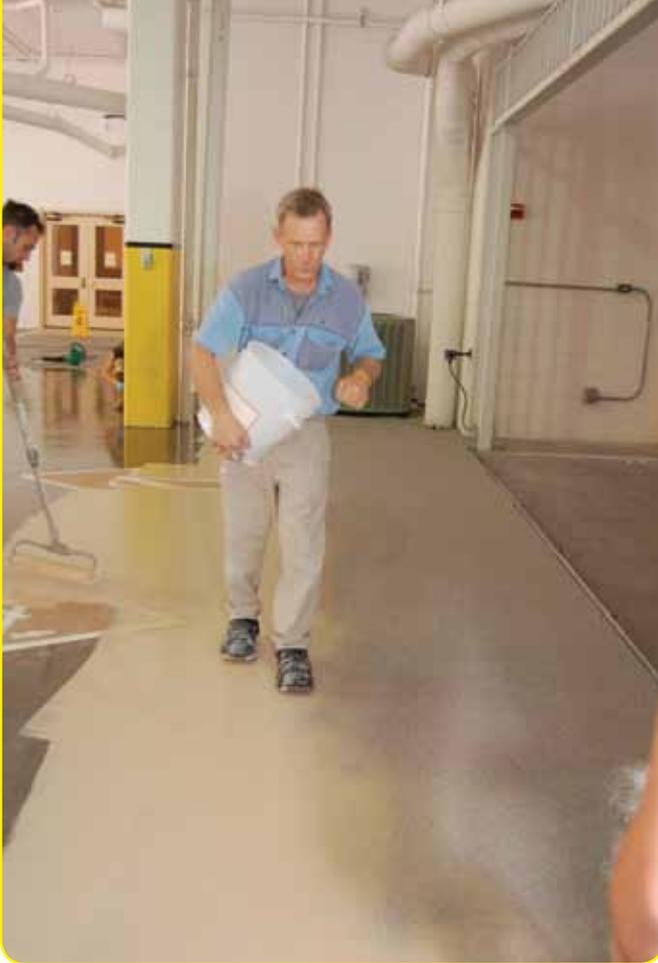
LEFT ◀ The specs called for a custom quartz mixture in a three-color blend of white, buff, and black. “One crew member hand-broadcast the quartz over the entire floor,” says Plumb. “We used leaf blowers to blow any loose quartz into the corners to be recovered for use again.”

The quartz mixture was a three-color blend of white, buff, and black. “One crew member hand-broadcast the quartz over

the entire floor. We used leaf blowers to blow any loose quartz into the corners to be recovered for use again.”

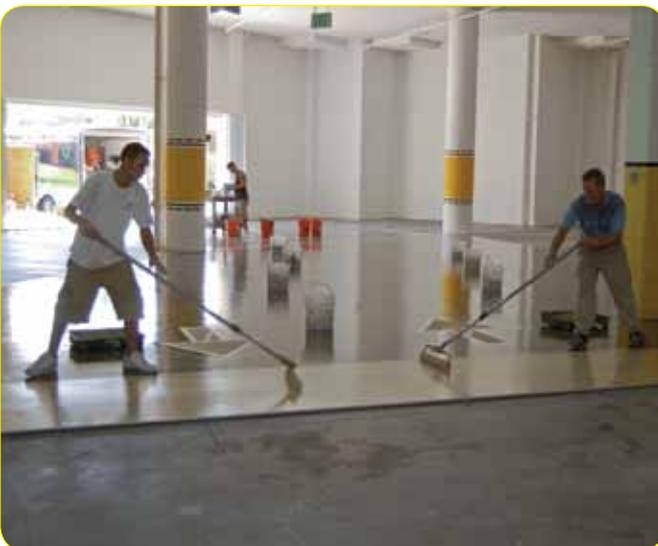
ABOVE ▲ The experienced Trademark crew not only had a tight project window, they had to work quickly because of the product itself. “You gotta work fast with polyaspartics because they dry so fast,” Plumb explains.

“The next coat was squeegeed on with 18” (45.72cm) EPDM squeegees in small amounts as before. You gotta work fast with polyaspartics because they dry so fast.” Plumb explains that this clear coat of SpartaFlex was poured on at a DFT of “at least 6 mils (0.152mm).” He continues, “When it was dry to recoat — about two hours — we were back on the floor for the final coat: another clear coat of SpartaFlex poured on at 3 mils (0.08mm) DFT. This time, however, we rolled in the opposite direction from the first clear coat. Within one hour we were walking on the new floor.”

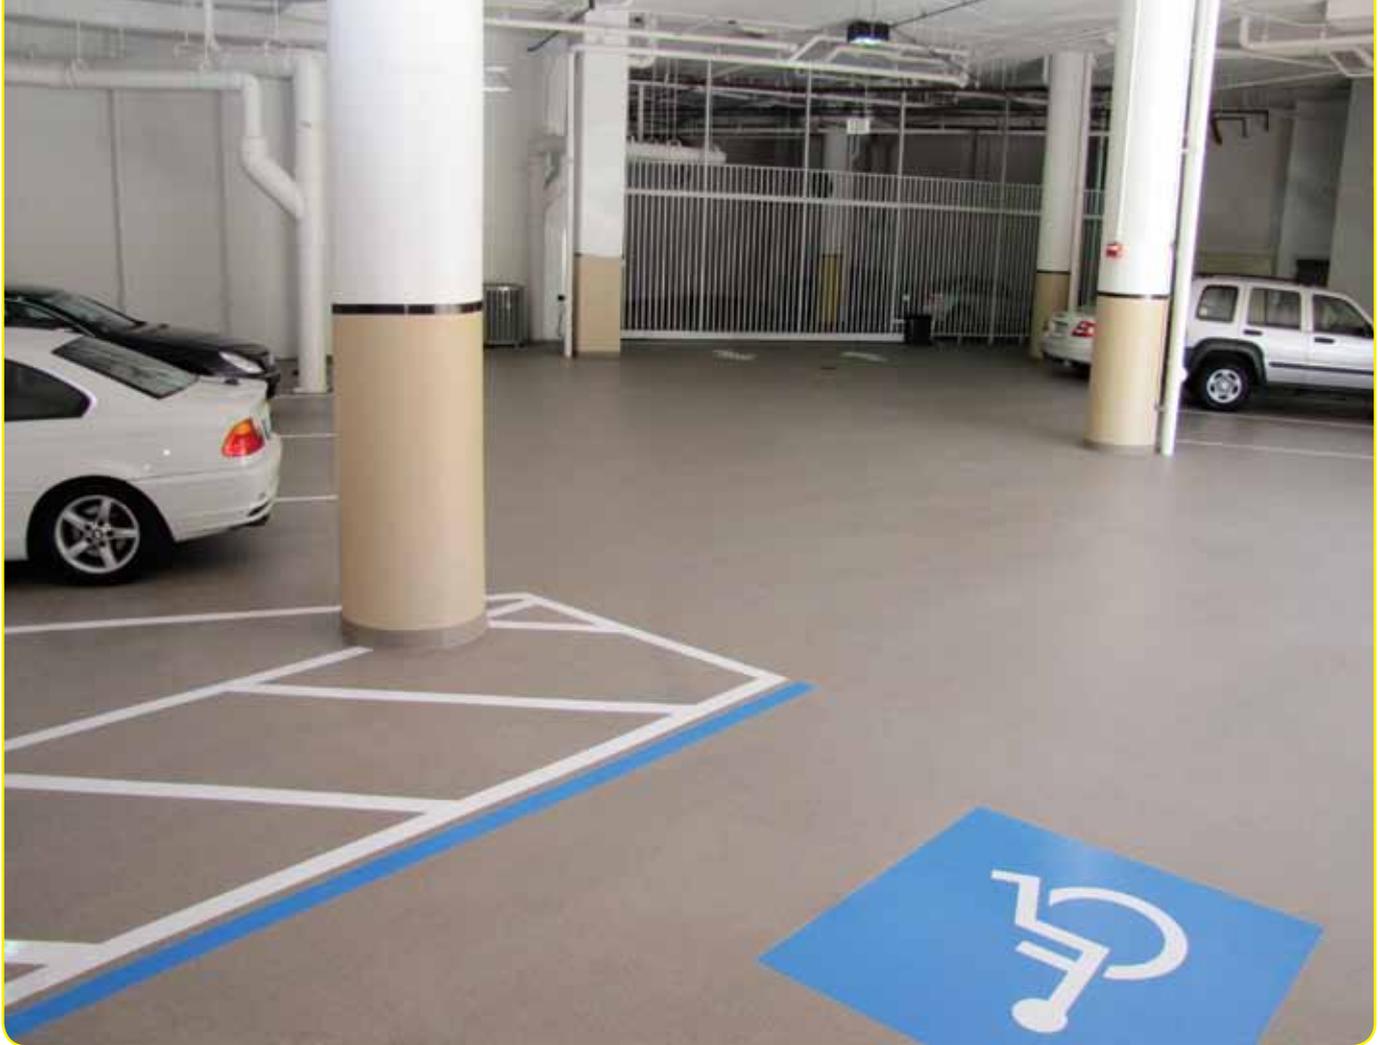
ABOVE ▲ The condo residents were so impressed with their new garage floor that they decided to redo the parking garage walls as well.

Plumb has reason to be proud. Not only were the owners impressed with the recoated parking garage and the crew’s hard work, but the Trademark team turned the completed deck back over in four days rather than the allotted five. “We told them that they could be back to driving on it within 24 hours, but they wanted to keep it closed for an extra day to have their maintenance crew repaint the walls.” Why not? When the floor looks show-room new, the walls should too.
